# Manhole Inspection Summary

Manhole # S25KK\_009MH

**Location** Address: **2323 DRUID HILL AVE**

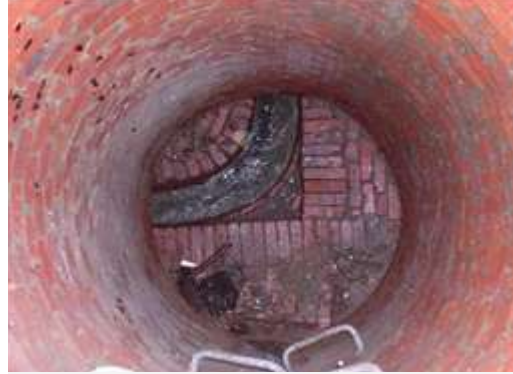
Top View

☐ Parged ☒ **Debris** (not Condition related)

**Steps** Count: **5** Missing: **0** ☒ **Corroded**

Corroded steps. Bench debris.

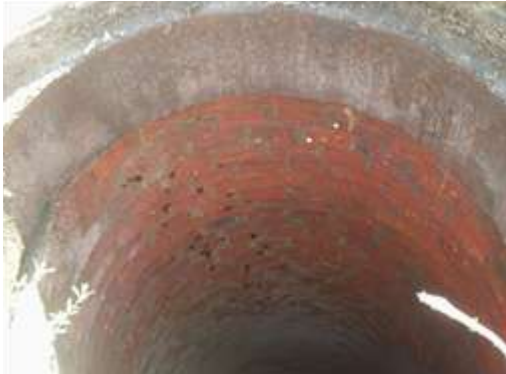
Defect

☒ **Leaks**

Infiltration: ☐ None ☒ **Joint** ☐ Cracks ☐ Mortar ☐ Roots ☐ Wall

Infiltration: ☐ None ☐ Joint ☐ Cracks ☒ **Mortar** ☐ Roots ☒ **Wall**

Frame leaks. Adjustment and Barrel infiltration - other side.

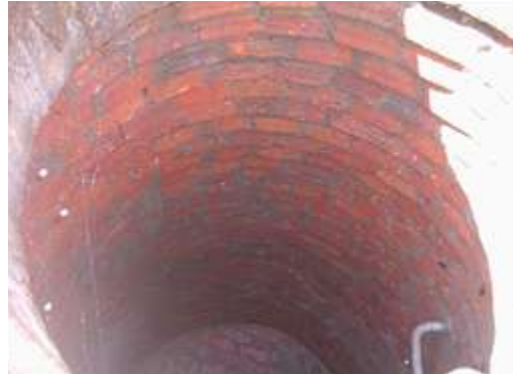
Defect

Frame leaks. Adjustment and Barrel infiltration.

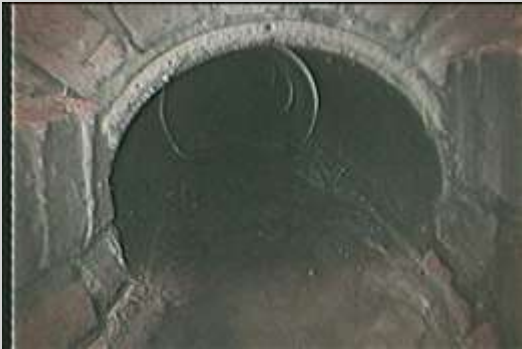
### 10 in. Circular Gravity Sewer Pipe Out @ 12 O'Clock

Infiltration: **Evidence** Pipe Seal Cond: **Unknown**

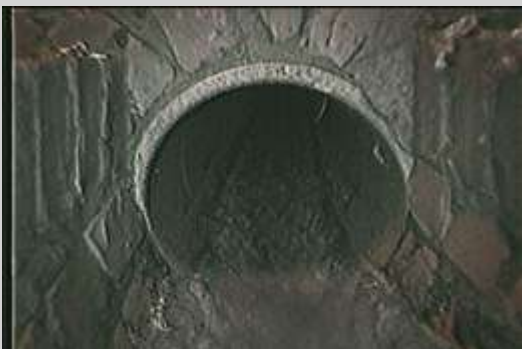
### 8 in. Circular Gravity Sewer Pipe In @ 9 O'Clock

Condition: ☐ Sound ☐ Cracked ☐ Root Intrusion ☒ **Deteriorated** ☐ Leaks ☐ Debris

Channel deterioration.

Infiltration: **None** Pipe Seal Cond: **Cracked**
